**Flood Control Project Maintenance
Levee Inspections**
LMA District Cover Sheet
Spring 2017 Levee Inspection Results

Reclamation District No. 0349 Sutter Island

Spring 2017 Levee Inspection Results

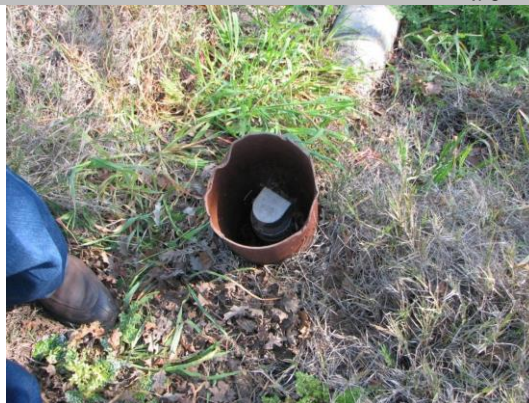
Photo 3 of 3 : UCIP_SP_2017_21673_36852.jpg

Comment Code						
Inspector Comment						
FS_ID:21673						
DS_ID:24232						
EP_NO: N/A						
Repair Type: Non-Urgent						
Crossing Status: Found						
UCIP Comments: No records were found during initial desk study--need to contact owner to obtain permit number authorizing work. Unable to determine if filter system is part of crossing appurtenances. If crossing is no longer used by owner, the owner will need to coordinate with DWR Inspector and CVFPB to remove crossing according to Title 23 requirements. Dense vegetation limits the inspector's visibility to identify signs of pipe failure (leaks) through the levee slopes. Recommend removing vegetation along pipe alignment to conduct proper inspection of structure and appurtenances. Note date on photos should be 3/18/09 not 7/26/08 camera metadata is incorrect.						
FIELD_STRUCT_DESC: 12-inch pipe through the levee, approximately 2.0 feet below the crown. Pipe changes diameter, 10-inch along both shoulders and 8-inch diameter exit on waterward side. Pipe exposed along both slopes. Pump on waterward side. Filtration system and power pole on landward side. Rock revetment on waterward slope.

View of siphon breaker.

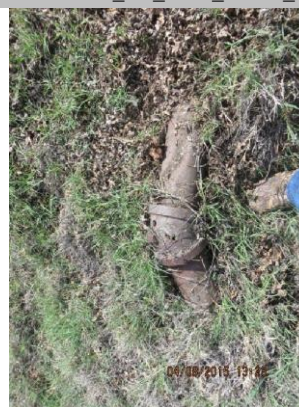
Photo 2 of 2 : UCIP_SP_2017_44335_73720.jpg

LM Start	1.17	Rating **	M	Issue No.	93 (cont)
LM End	1.17	Issue Type +	En	Location *	LS

Pipe visible on LS slope.

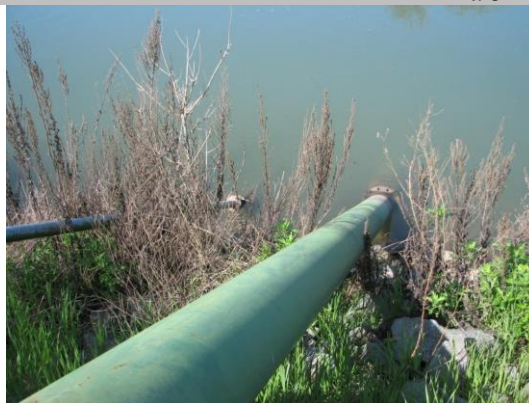
Photo 3 of 3 : UCIP_SP_2017_47042_36858.jpg

Comment Code						
Inspector Comment						
FS_ID:47042 DS_ID:24168 EP_NO: 11744 Repair Type: Non-Urgent Crossing Status: Found UCIP Comments: Dense vegetation limits the inspector's visibility to identify signs of pipe failure (leaks) through the levee slopes. Recommend removing vegetation along pipe alignment to conduct proper inspection of structure and appurtenances. Note date on photos should be 3/18/09 not 7/26/08 camera metadata is incorrect. FIELD_STRUCT_DESC: 2 of 2: 14-inch steel irrigation pipe and 2-inch electric conduit through the levee, both 4.4 feet below the crown. Reduced to 12-inch steel pipe under both levee slopes. Steel cutoff wall around pipe at center of levee. Siphon breaker at landward shoulder. Slant pump on waterward side with staircase access. Discharge structure at landward toe. Rock revetment on waterward slope. (Permit No. 11744-1976) FS Date: 3/19/2009

Rip rap along the waterward toe.

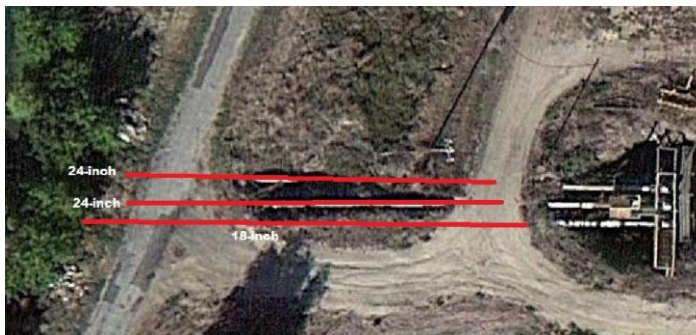
Photo 1 of 2 : UCIP_SP_2017_43446_36725.jpg

FS_ID:43446
DS_ID:24229
EP_NO: 2954
Repair Type: Non-Urgent
Crossing Status: Found
UCIP Comments: Dense vegetation limits the inspector's visibility to identify signs of pipe failure (leaks) through the levee slopes. Recommend removing vegetation along pipe alignment to conduct proper inspection of structure and appurtenances. Note date on photos should be 3/18/09 not 7/26/08 camera metadata is incorrect.
FIELD_STRUCT_DESC: [R.D. No. 349 Drainage Pumping Plant] 1 of 3: 18-inch pipe through the levee, 7.8 feet below the crown. Siphon breakers on waterward slope. Pumps on platform on landward side.
FS Date: 3/19/2009

Aerial map showing alignment of 18-inch pipe.

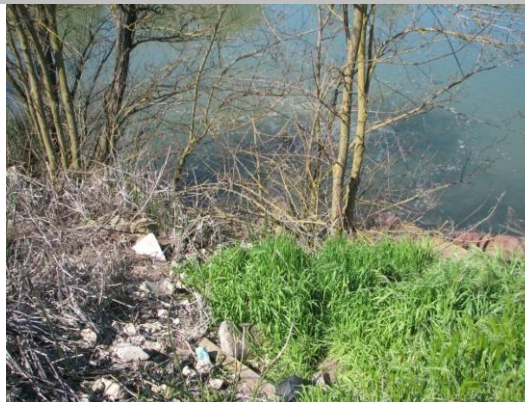
Photo 2 of 2 : UCIP_SP_2017_43446_36726.jpg

View of all 3 pipes through levee and visible on waterward toe.

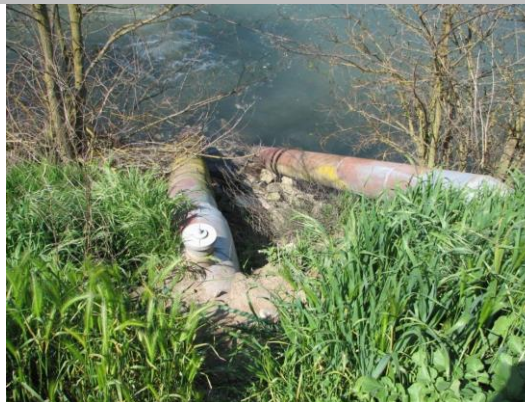
Photo 2 of 3 : UCIP_SP_2017_43445_36727.jpg

FS_ID:43445
DS_ID:24228
EP_NO: 2954
Repair Type: Non-Urgent
Crossing Status: Found
UCIP Comments: Dense vegetation limits the inspector's visibility to identify signs of pipe failure (leaks) along the slope. Recommend removing vegetation along pipe alignment to conduct proper inspection of structure and appurtenances. Note date on photos should be 3/18/09 not 7/26/08 camera metadata is incorrect.
FIELD_STRUCT_DESC: [R.D. No. 349 Drainage Pumping Plant] 2 of 3: 24-inch pipe through the levee, 7.8 feet below the crown. Siphon breakers on waterward slope. Pumps on platform on landward side.
FS Date: 3/19/2009

View of pipe on waterward side--pipe running. Siphon breaker visible on pipe.

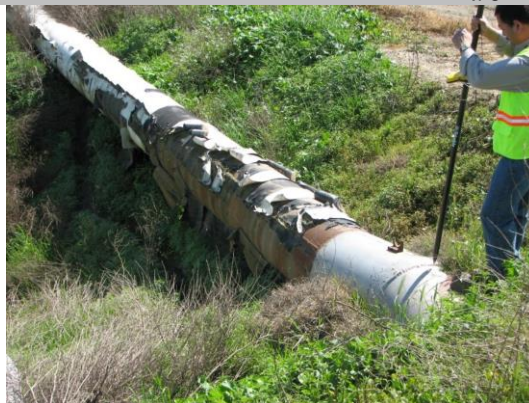
Photo 3 of 3 : UCIP_SP_2017_43445_36728.jpg

Comment Code						
Inspector Comment						
FS_ID:43445						
DS_ID:24228						
EP_NO: 2954						
Repair Type: Non-Urgent						
Crossing Status: Found						
UCIP Comments: Dense vegetation limits the inspector's visibility to identify signs of pipe failure (leaks) along the slope. Recommend removing vegetation along pipe alignment to conduct proper inspection of structure and appurtenances. Note date on photos should be 3/18/09 not 7/26/08 camera metadata is incorrect.						
FIELD_STRUCT_DESC: [R.D. No. 349 Drainage Pumping Plant] 2 of 3: 24-inch pipe through the levee, 7.8 feet below the crown. Siphon breakers on waterward slope. Pumps on platform on landward side.						
FS Date: 3/19/2009

Pipe is wrapped--unwrapped coating.

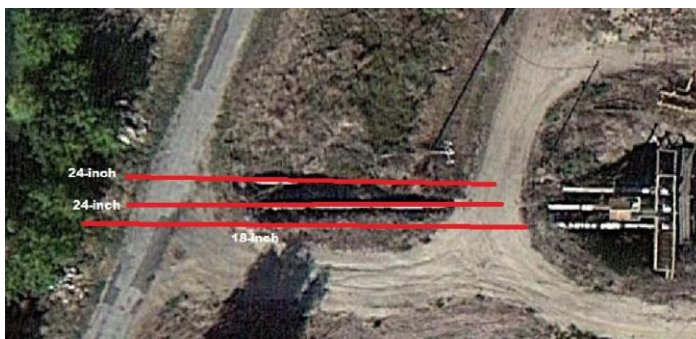
Photo 1 of 3 : UCIP_SP_2017_21632_36733.jpg

Comment Code					
Inspector Comment					
FS_ID:21632					
DS_ID:24171					
EP_NO: 2954					
Repair Type: Non-Urgent					
Crossing Status: Found					
UCIP Comments: Dense vegetation limits the inspector's visibility to identify signs of pipe failure (leaks) along the slope. Recommend removing vegetation along pipe alignment to conduct proper inspection of structure and appurtenances. Note date on photos should be 3/18/09 not 7/26/08 camera metadata is incorrect.					
FIELD_STRUCT_DESC: [R.D. No. 349 Drainage Pumping Plant] 3 of 3: 24-inch pipe through the levee, 7.8 feet below the crown. Metal cutoff wall around pipe at landward shoulder. Siphon breakers on waterward slope. Two anchor posts driven into levee on each side of pipe. Pumps on platform on landward side. (Permit No. 2954-1959)					
FS Date: 3/19/2009

Aerial view of all 3 pipes through levee.

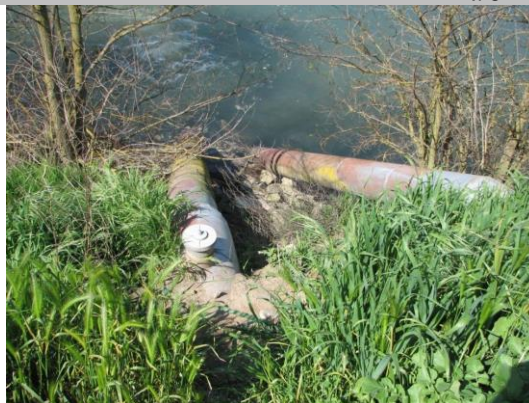
Photo 2 of 3 : UCIP_SP_2017_21632_36731.jpg

Comment Code						
Inspector Comment						
FS_ID:21632 DS_ID:24171 EP_NO: 2954 Repair Type: Non-Urgent Crossing Status: Found UCIP Comments: Dense vegetation limits the inspector's visibility to identify signs of pipe failure (leaks) along the slope. Recommend removing vegetation along pipe alignment to conduct proper inspection of structure and appurtenances. Note date on photos should be 3/18/09 not 7/26/08 camera metadata is incorrect. FIELD_STRUCT_DESC: [R.D. No. 349 Drainage Pumping Plant] 3 of 3: 24-inch pipe through the levee, 7.8 feet below the crown. Metal cutoff wall around pipe at landward shoulder. Siphon breakers on waterward slope. Two anchor posts driven into levee on each side of pipe. Pumps on platform on landward side. (Permit No. 2954-1959) FS Date: 3/19/2009

View of waterward side--2-24 inch pipes.

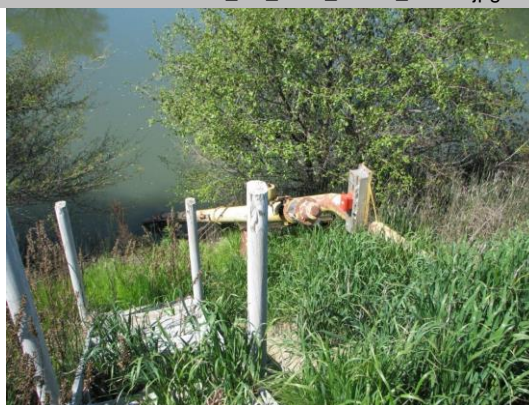
Photo 1 of 3 : UCIP_SP_2017_47045_36736.jpg

Comment Code					
Inspector Comment					
FS_ID:47045					
DS_ID:24172					
EP_NO: N/A					
Repair Type: Non-Urgent					
Crossing Status: Found					
UCIP Comments: Dense vegetation limits the inspector's visibility to identify signs of pipe failure (leaks) through the levee slopes.					
Recommend removing vegetation along pipe alignment to conduct proper inspection of structure and appurtenances. Note date on photos should be 3/18/09 not 7/26/08 camera metadata is incorrect.					
FIELD_STRUCT_DESC: 1 of 2: 12-inch pipe and 2-inch electrical conduit through the levee, both 8.0 feet below the crown. Siphon breaker in pipe riser on landward slope. Concrete standpipe at landward toe. Pump on waterward side with stairway access.					
FS Date: 3/19/2009

View of waterward side--pump, pipe, control panel, and stairway.

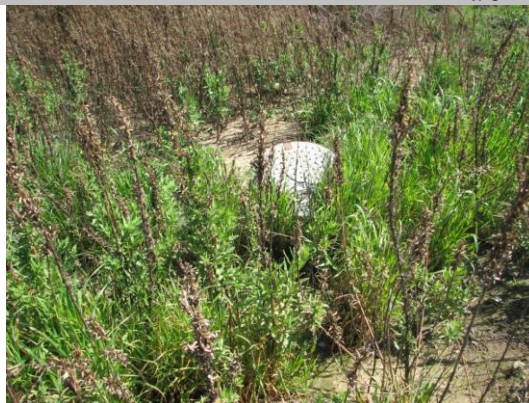
Photo 2 of 3 : UCIP_SP_2017_47045_36735.jpg

Comment Code						
Inspector Comment						
FS_ID:47045 DS_ID:24172 EP_NO: N/A Repair Type: Non-Urgent Crossing Status: Found UCIP Comments: Dense vegetation limits the inspector's visibility to identify signs of pipe failure (leaks) through the levee slopes. Recommend removing vegetation along pipe alignment to conduct proper inspection of structure and appurtenances. Note date on photos should be 3/18/09 not 7/26/08 camera metadata is incorrect. FIELD_STRUCT_DESC: 1 of 2: 12-inch pipe and 2-inch electrical conduit through the levee, both 8.0 feet below the crown. Siphon breaker in pipe riser on landward slope. Concrete standpipe at landward toe. Pump on waterward side with stairway access. FS Date: 3/19/2009

Stand pipe located on landward shoulder--pipe locked.

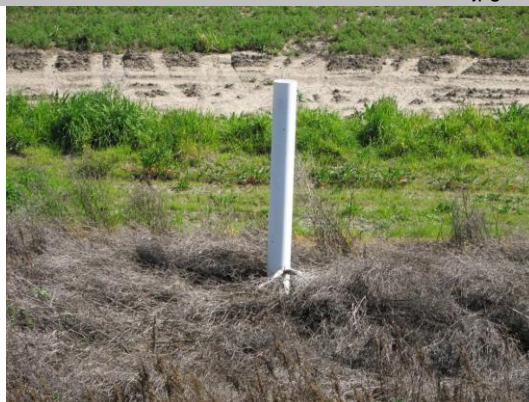
Photo 3 of 3 : UCIP_SP_2017_47045_36737.jpg

Tall thin stand pipe located on landward side--unable to find pipe.

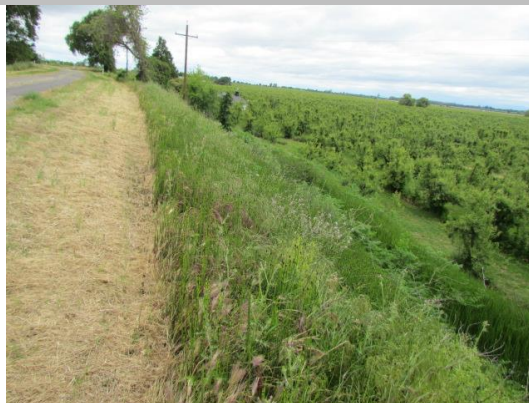
Photo 1 of 1 : SP_2017_RD0349_206_47_20170522_00076.jpg

LM Start	1.89	Rating **	U	Issue No.	47
LM End	6.33	Issue Type +	Ma	Location *	LS
Category	Earthen Levee			GPS Latitude/Longitude	
				Start	End
Item	Vegetation			38.281177 °	38.328778 °
				-121.600830 °	-121.579013 °
DWR ID	DWR_RD0349_03_s_2017_47				
Comment Code					
V1 : Control annual grass and weeds on the levee slopes and easements.					
Inspector Comment					
Control the annual grasses and weeds from the landside slope and berm.

RD 349 Unit 4 looking from levee mile 1.89 landside slope and berm.

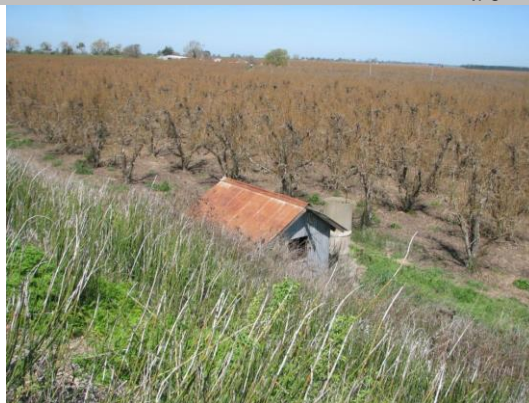
Photo 1 of 2 : UCIP_SP_2017_21634_36739.jpg

Comment Code					
Inspector Comment					
FS_ID:21634 DS_ID:24173 EP_NO: N/A Repair Type: Non-Urgent Crossing Status: Found UCIP Comments: Dense vegetation limits the inspector's visibility to identify signs of pipe failure (leaks) through the levee slopes. Recommend removing vegetation along pipe alignment to conduct proper inspection of structure and appurtenances. Note date on photos should be 3/18/09 not 7/26/08 camera metadata is incorrect. FIELD_STRUCT_DESC: 8-inch pipe through the levee, 6.7 feet below the crown. Pump in pumphouse and concrete standpipe at the landward toe. (USACE-1959). This entry matches the Drainage or Irrigation Structure referenced in O&M manual (HLM 2.1). FS Date: 3/19/2009

View of landward side--pump house and stand pipe.

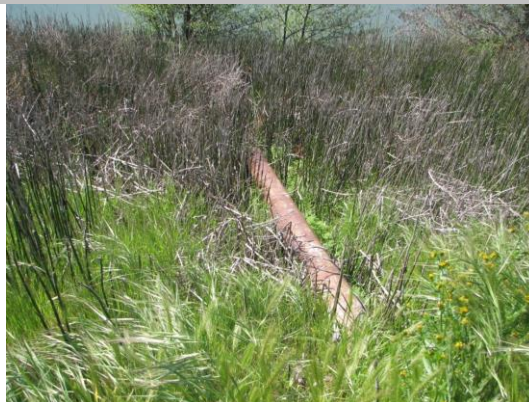
Photo 2 of 2 : UCIP_SP_2017_21634_36738.jpg

View of waterward side--dense vegetation limits inspection.

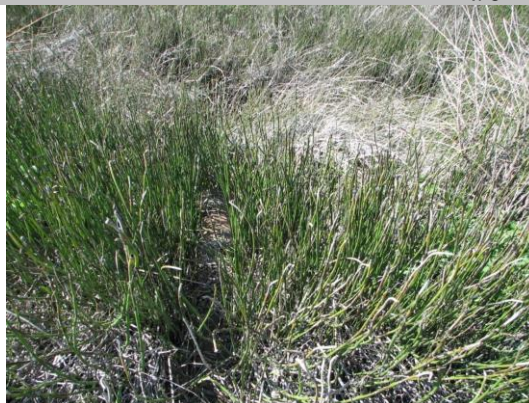
Photo 1 of 3 : UCIP_SP_2017_43423_36866.jpg

FS_ID:43423
DS_ID:24176
EP_NO: N/A
Repair Type: Non-Urgent
Crossing Status: Found
UCIP Comments: Need to contact owner--If crossing is no longer used by owner, the owner will need to coordinate with DWR Inspector and CVFPB to remove crossing according to Title 23 requirements. Dense vegetation limits the inspector's visibility to identify signs of pipe failure (leaks) through the levee slopes. Recommend removing vegetation along pipe alignment to conduct proper inspection of structure and appurtenances. Note date on photos should be 3/18/09 not 7/26/08 camera metadata is incorrect.
FIELD_STRUCT_DESC: *ABANDONED* 10-inch pipe through the levee, 8.2 feet below the crown. Pipe has plate welded on the waterward end. 3-inch galvanized pipe runs parallel to 10-inch pipe. Abandoned tank on waterward slope. Distribution box and concrete standpipe at landward toe. (USACE-1959). This entry matches the Drainage or Irrigation Structure referenced in O&M manual (HLM 2.7).

View of waterward side--dense vegetation covers slope.

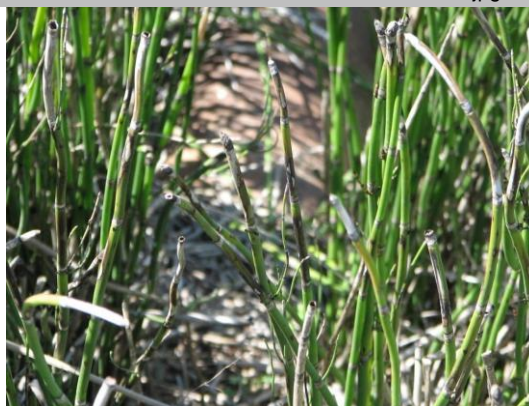
Photo 2 of 3 : UCIP_SP_2017_43423_36865.jpg

Pipe visible on waterward side.

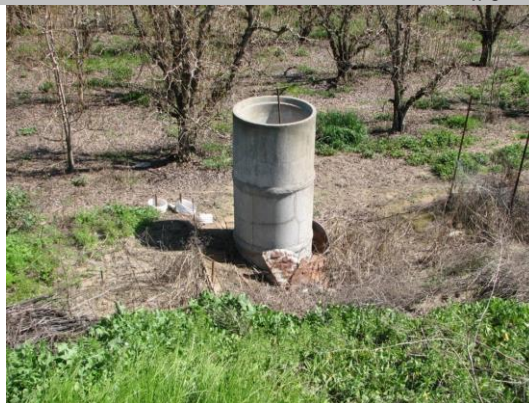
Photo 3 of 3 : UCIP_SP_2017_43423_36867.jpg

Item	DWR UCIP Field Study			38.289633 °	38.289633 °	
				-121.603313 °	-121.603313 °	
DWR ID						
Comment Code						
Inspector Comment						
FS_ID:43423 DS_ID:24176 EP_NO: N/A Repair Type: Non-Urgent Crossing Status: Found UCIP Comments: Need to contact owner--If crossing is no longer used by owner, the owner will need to coordinate with DWR Inspector and CVFPB to remove crossing according to Title 23 requirements. Dense vegetation limits the inspector's visibility to identify signs of pipe failure (leaks) through the levee slopes. Recommend removing vegetation along pipe alignment to conduct proper inspection of structure and appurtenances. Note date on photos should be 3/18/09 not 7/26/08 camera metadata is incorrect. FIELD_STRUCT_DESC: *ABANDONED* 10-inch pipe through the levee, 8.2 feet below the crown. Pipe has plate welded on the waterward end. 3-inch galvanized pipe runs parallel to 10-inch pipe. Abandoned tank on waterward slope. Distribution box and concrete standpipe at landward toe. (USACE-1959). This entry matches the Drainage or Irrigation Structure referenced in O&M manual (HLM 2.7). FS Date: 3/19/2009

Stand pipe located on landward toe.

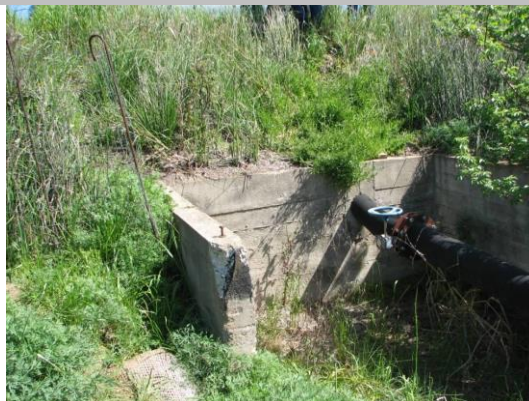
Photo 2 of 3 : UCIP_SP_2017_43424_36871.jpg

Comment Code					
Inspector Comment					
FS_ID:43424 DS_ID:24177 EP_NO: N/A Repair Type: Non-Urgent Crossing Status: Found UCIP Comments: 2007 Erosion Repair Site location?--Need to contact owner to determine if crossing is still in use. If crossing is no longer used by owner, the owner will need to coordinate with DWR Inspector and CVFPB to remove crossing according to Title 23 requirements. Dense vegetation limits the inspector's visibility to identify signs of pipe failure (leaks) through the levee slopes. Recommend removing vegetation along pipe alignment to conduct proper inspection of structure and appurtenances. Note date on photos should be 3/18/09 not 7/26/08 camera metadata is incorrect. FIELD_STRUCT_DESC: *ABANDONED* 8-inch pipe through the levee, 8.7 feet below the crown. Headwall and gate valve on the landward side. FS Date: 3/19/2009

View of waterward side--headwall, pipe, and gate valve.

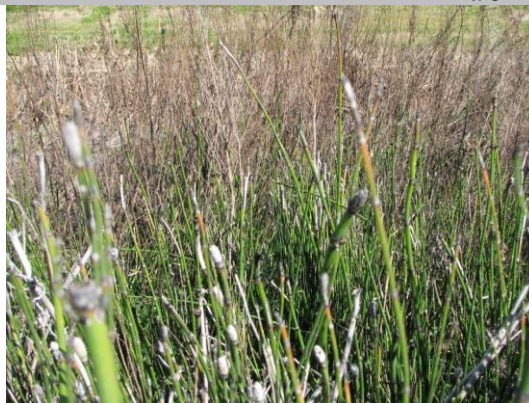
Photo 3 of 3 : UCIP_SP_2017_43424_36868.jpg

Item	DWR UCIP Field Study			38.292557 °		38.292557 °
				-121.603767 °		-121.603767 °
DWR ID						
Comment Code						
Inspector Comment						
FS_ID:43424 DS_ID:24177 EP_NO: N/A Repair Type: Non-Urgent Crossing Status: Found UCIP Comments: 2007 Erosion Repair Site location?--Need to contact owner to determine if crossing is still in use. If crossing is no longer used by owner, the owner will need to coordinate with DWR Inspector and CVFPB to remove crossing according to Title 23 requirements. Dense vegetation limits the inspector's visibility to identify signs of pipe failure (leaks) through the levee slopes. Recommend removing vegetation along pipe alignment to conduct proper inspection of structure and appurtenances. Note date on photos should be 3/18/09 not 7/26/08 camera metadata is incorrect. FIELD_STRUCT_DESC: *ABANDONED* 8-inch pipe through the levee, 8.7 feet below the crown. Headwall and gate valve on the landward side. FS Date: 3/19/2009

View of landward side--dense vegetation on slope limits inspection.

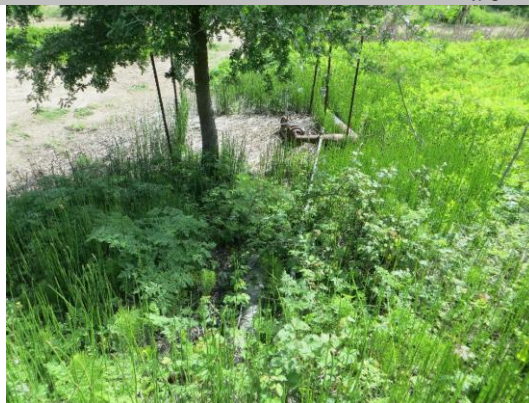
Photo 1 of 3 : UCIP_SP_2017_50014_73743.jpg

FS_ID:50014
DS_ID:24178
EP_NO: 6321
Repair Type: Urgent
Crossing Status: Found
UCIP Comments: 8/17/2016 Unable to determine condition of crossing due to dense vegetation on both WS and LS. Need to contact owner to determine status of crossing. Unable to confirm if WS pipe capped with metal plate. (DWR UCIP - omagana)4/08/2015 Appears abandoned and if so should be done so properly. Pipe open at LS toe. Unable to verify if plate is welded over WS end. (DWR UCIP - omagana)
FIELD_STRUCT_DESC: *ABANDONED* 8-inch steel irrigation pipe through the levee, 4.5 feet below the crown. Corrugated metal cutoff wall around pipe at center of levee. Siphon breaker is located on the waterside (WS) shoulder. Pump is located on the landside (LS). Gate valve is located on the WS. 1.5-inch filler pipe at same location. Plate welded to WS end (Permit No. 6321, 1969 - B.C. Wheeler).
FS Date: 8/17/2016

Pipe and pump platform on LS toe.

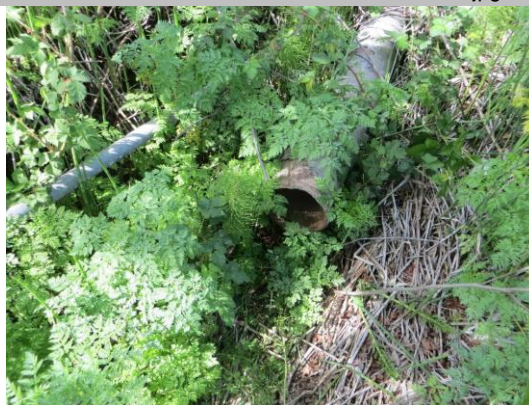
Photo 2 of 3 : UCIP_SP_2017_50014_73742.jpg

1.5-inch filler pipe and 8-inch steel irrigation pipe at LS toe.

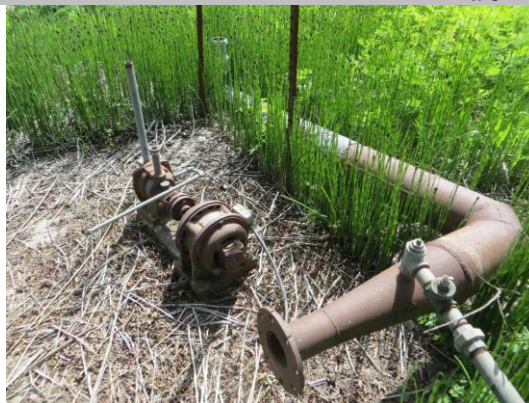
Photo 3 of 3 : UCIP_SP_2017_50014_73741.jpg

Item	DWR UCIP Field Study			38.294080 °	38.294080 °	
				-121.604260 °	-121.604260 °	
DWR ID						
Comment Code						
Inspector Comment						
FS_ID:50014 DS_ID:24178 EP_NO: 6321 Repair Type: Urgent Crossing Status: Found UCIP Comments: 8/17/2016 Unable to determine condition of crossing due to dense vegetation on both WS and LS. Need to contact owner to determine status of crossing. Unable to confirm if WS pipe capped with metal plate. (DWR UCIP - omagana)4/08/2015 Appears abandoned and if so should be done so properly. Pipe open at LS toe. Unable to verify if plate is welded over WS end. (DWR UCIP - omagana) FIELD_STRUCT_DESC: *ABANDONED* 8-inch steel irrigation pipe through the levee, 4.5 feet below the crown. Corrugated metal cutoff wall around pipe at center of levee. Siphon breaker is located on the waterside (WS) shoulder. Pump is located on the landside (LS). Gate valve is located on the WS. 1.5-inch filler pipe at same location. Plate welded to WS end (Permit No. 6321, 1969 - B.C. Wheeler). FS Date: 8/17/2016

Abandoned pump at LS toe.

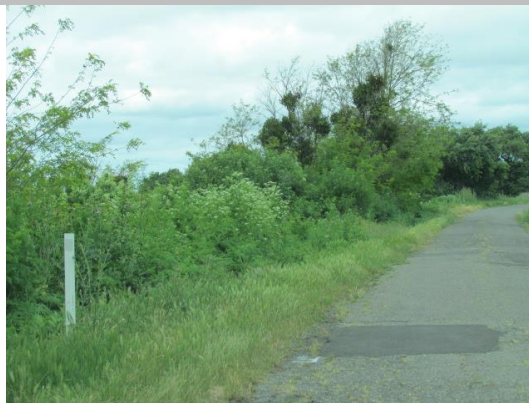
Photo 1 of 1 : SP_2017_RD0349_206_73_20170522_00080.jpg

LM Start	3.01	Rating **	U	Issue No.	73
LM End	6.33	Issue Type +	Ma	Location *	WS
Category	Earthen Levee			GPS Latitude/Longitude	
				Start	End
Item	Vegetation			38.296033 °	38.328778 °
				-121.604735 °	-121.579013 °
DWR ID	DWR_RD0349_03_s_2017_73				
Comment Code					
V1 : Control annual grass and weeds on the levee slopes and easements.					
Inspector Comment					
Control the annual grasses from the levee slope and shoulder.

RD 349 Unit 4 waterside shoulder and slope levee mile 3.01-6.33.

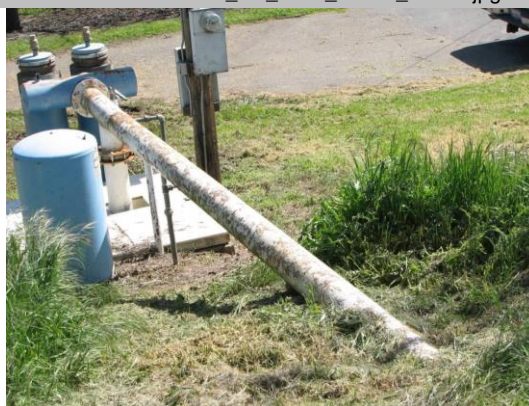
Photo 3 of 3 : UCIP_SP_2017_44389_36874.jpg

LM Start	3.34	Rating **	M	Issue No.	104 (cont)	
LM End	3.34	Issue Type +	En	Location *	WS	
Category	Supplemental			GPS Latitude/Longitude		
				Start		End
Item	DWR UCIP Field Study			38.299703 °		38.299703 °
				-121.601112 °		-121.601112 °
DWR ID						
Comment Code						
Inspector Comment						
FS_ID:44389 DS_ID:24179 EP_NO: N/A Repair Type: Non-Urgent Crossing Status: Found UCIP Comments: Crossing altered--need to contact owner to obtain permit number authorizing work. Dense vegetation limits the inspector's visibility to identify signs of pipe failure (leaks) along the slope. Recommend removing vegetation along pipe alignment to conduct proper inspection of structure and appurtenances. Note date on photos should be 3/18/09 not 7/26/08 camera metadata is incorrect. FIELD_STRUCT_DESC: *DELETE* FS Date: 4/9/2015

View of landward side.

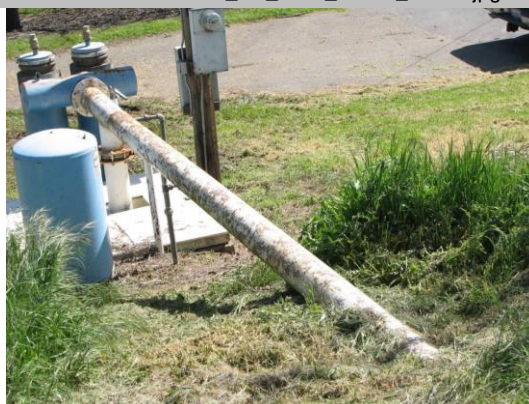
Photo 1 of 2 : UCIP_SP_2017_44390_73745.jpg

LM Start	3.34	Rating **	M	Issue No.	105
LM End	3.34	Issue Type +	En	Location *	WS
Category	Supplemental			GPS Latitude/Longitude	
				Start	End
Item	DWR UCIP Field Study			38.299718 °	38.299718 °
				-121.601095 °	-121.601095 °
DWR ID					
Comment Code					
Inspector Comment					
FS_ID:44390					
DS_ID:24214					
EP_NO: N/A					
Repair Type: Non-Urgent					
Crossing Status: Found					
UCIP Comments: Walway and pier abandoned and appears to be a hazard that should be removed.					
FIELD_STRUCT_DESC: 10-inch steel irrigation pipe through the levee 5.8-feet below the crown. Pump, butterfly valve, and electrical panel on WS slope. Pier and walkway next to pump on WS slope. Power pole, filters, and distribution box at LS toe.					
FS Date: 4/9/2015

Pipe, filter system, powerpole, and distribution box at LS toe.

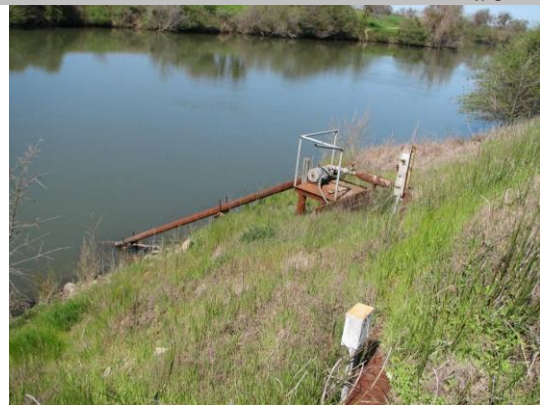
Photo 1 of 3 : UCIP_SP_2017_21644_36780.jpg

Comment Code					
Inspector Comment					
FS_ID:21644 DS_ID:24180 EP_NO: 9290 Repair Type: Non-Urgent Crossing Status: Found UCIP Comments: Dense vegetation limits the inspector's visibility to identify signs of pipe failure (leaks) through the levee slopes. Recommend removing vegetation along pipe alignment to conduct proper inspection of structure and appurtenances. FIELD_STRUCT_DESC: 10-inch steel pipe and 1.5-inch steel electrical conduit through the levee, both 4.0 feet below the crown. Steel cutoff wall around pipe and conduit at center of levee. Pump and gate valve on waterward slope. 6-inch intake pipe extends from pump into channel. Distribution system at landward toe. (Permit No. 9290-1975) FS Date: 3/19/2009

View of waterward side.

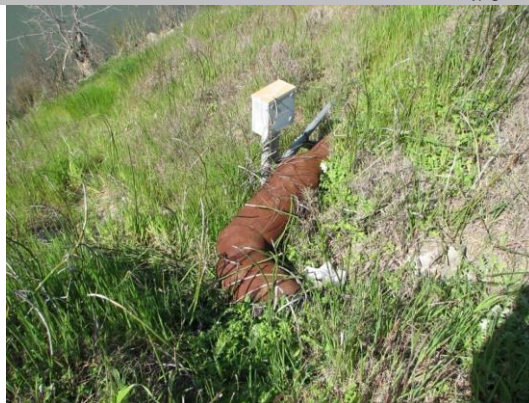
Photo 2 of 3 : UCIP_SP_2017_21644_36778.jpg

90 elbow at daylight and continues along slope and connects to pump.

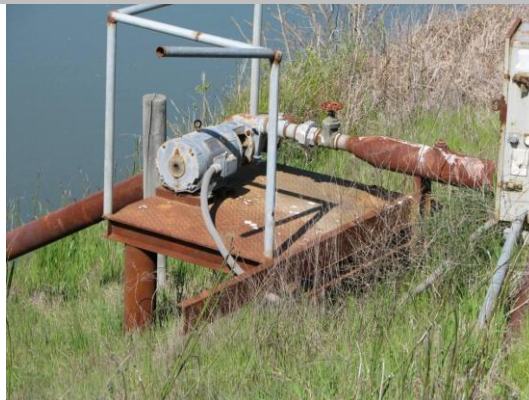
Photo 3 of 3 : UCIP_SP_2017_21644_36781.jpg

Appurtenances located on waterward slope.

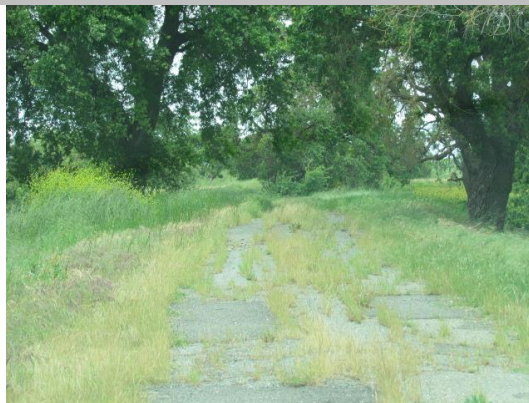
Photo 1 of 1 : SP_2017_RD0349_206_50_20170522_00081.jpg

LM Start	3.99	Rating **	U	Issue No.	50
LM End	6.33	Issue Type +	Ma	Location *	CR
Category	Earthen Levee			GPS Latitude/Longitude	
				Start	End
Item	Vegetation			38.307972 °	38.328778 °
				-121.597037 °	-121.579013 °
DWR ID	DWR_RD0349_03_s_2017_50				
Comment Code					
V9 : Keep the crown roadway free of vegetation.					
Inspector Comment					
Keep the crown roadway free of vegetation.

RD 349 Unit 4 levee mile 3.99 -6.33 crown roadway.

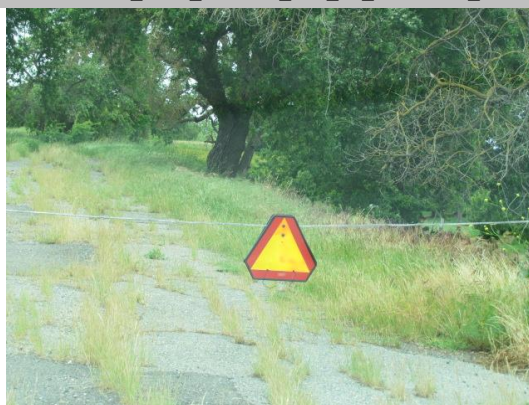
Photo 1 of 1 : SP_2017_RD0349_206_25_20170522_00082.jpg

LM Start	3.99	Rating **	U	Issue No.	25
LM End	3.99	Issue Type +	En	Location *	LS
Category	Earthen Levee			GPS Latitude/Longitude	
				Start	End
Item	Encroachments			38.307997 °	38.307997 °
				-121.597039 °	-121.597039 °
DWR ID	DWR_RD0349_03_s_2012_25				
Comment Code					
FE : Fence					
Inspector Comment					
Unauthorized cable gate crossing levee. Cable gates crossing the levee crown have been prohibited. This encroachment should be removed.

Cable crossings has been banned. They are unauthorized.

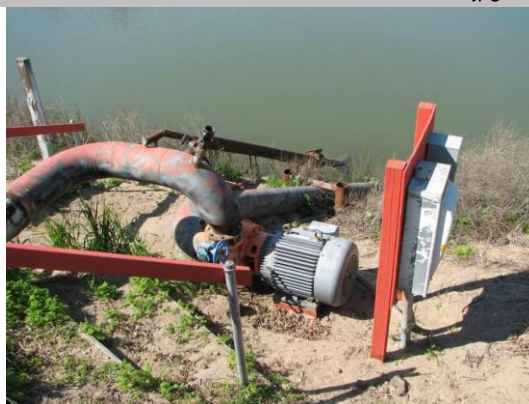
Photo 2 of 3 : UCIP_SP_2017_43457_36792.jpg

Comment Code					
Inspector Comment					
FS_ID:43457 DS_ID:24184 EP_NO: 8681 Repair Type: Non-Urgent Crossing Status: Found UCIP Comments: Need to contact owner. Is filter sytem located on landward side part of crossing. If so need permit number authorizing work. Also if crossing is no longer used by owner, the owner will need to coordinate with DWR Inspector and CVFPB to remove crossing according to Title 23 requirements. Dense vegetation limits the inspector's visibility to identify signs of pipe failure (leaks) through the levee slopes. Recommend removing vegetation along pipe alignment to conduct proper inspection of structure and appurtenances. Note date on photos should be 3/18/09 not 7/26/08 camera metadata is incorrect. FIELD_STRUCT_DESC: 2 of 2: 12-inch steel irrigation pipe through the levee, 4.3 feet feet below the crown. Steel cutoff wall around pipe at center of levee. Pump on platform and gate valve on the waterward slope. Exposed suction pipe from pump to channel. Rock revetment on waterward slope. (Permit No. 8681-1973) FS Date: 3/19/2009

Pump associated with 12-inch pipe.

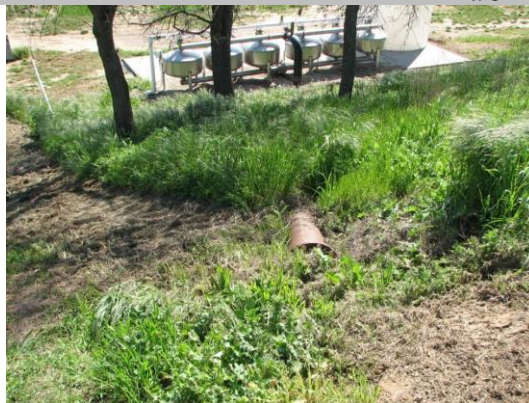
Photo 3 of 3 : UCIP_SP_2017_43457_36790.jpg

Comment Code					
Inspector Comment					
FS_ID:43457 DS_ID:24184 EP_NO: 8681 Repair Type: Non-Urgent Crossing Status: Found UCIP Comments: Need to contact owner. Is filter sytem located on landward side part of crossing. If so need permit number authorizing work. Also if crossing is no longer used by owner, the owner will need to coordinate with DWR Inspector and CVFPB to remove crossing according to Title 23 requirements. Dense vegetation limits the inspector's visibility to identify signs of pipe failure (leaks) through the levee slopes. Recommend removing vegetation along pipe alignment to conduct proper inspection of structure and appurtenances. Note date on photos should be 3/18/09 not 7/26/08 camera metadata is incorrect. FIELD_STRUCT_DESC: 2 of 2: 12-inch steel irrigation pipe through the levee, 4.3 feet feet below the crown. Steel cutoff wall around pipe at center of levee. Pump on platform and gate valve on the waterward slope. Exposed suction pipe from pump to channel. Rock revetment on waterward slope. (Permit No. 8681-1973) FS Date: 3/19/2009

View of pipe and filter system on landward side.

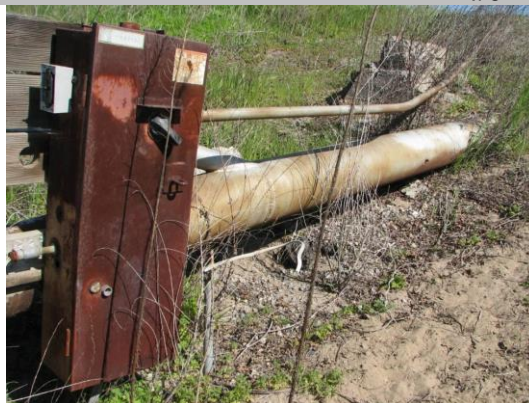
Photo 3 of 3 : UCIP_SP_2017_43459_36797.jpg

Comment Code					
Inspector Comment					
FS_ID:43459 DS_ID:24185 EP_NO: N/A Repair Type: Non-Urgent Crossing Status: Found UCIP Comments: No connection present--need to contact owner to determine if owner plans to use. If crossing is no longer in use owner will need to coordinate with DWR inspector and CVFPB to remove according to Title 23 requirements. Recommend removing vegetation along pipe alignment. Note date on photos should be 3/18/09 not 7/26/08 camera metadata is incorrect. FIELD_STRUCT_DESC: *ABANDONED* 10-inch steel irrigation pipe and 2-inch electrical conduit through the levee, both 2.8 feet below the crown. Abandoned pumps and gate valve on the waterward slope. Service pole on the landward slope. Concrete headwall on landward sdie. (USACE-1959). This entry matches the Drainage or Irrigation Structure referenced in O&M manual (HLM 4.8). FS Date: 3/19/2009

Pipe on waterward side.

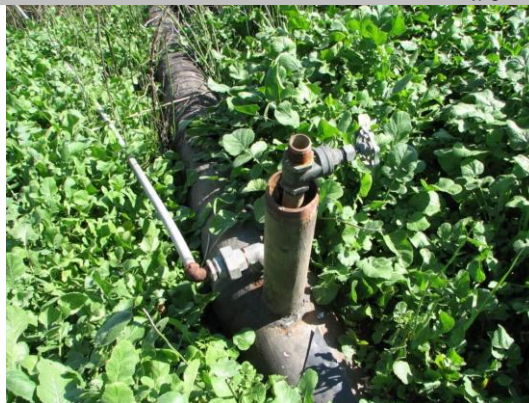
Photo 1 of 3 : UCIP_SP_2017_43431_36800.jpg

FS_ID:43431
DS_ID:24186
EP_NO: 15359
Repair Type: Non-Urgent
Crossing Status: Found
UCIP Comments: Dense vegetation limits the inspector's visibility to identify signs of pipe failure (leaks) through the levee slopes. Recommend removing vegetation along pipe alignment to conduct proper inspection of structure and appurtenances. Note date on photos should be 3/18/09 not 7/26/08 camera metadata is incorrect.
FIELD_STRUCT_DESC: 10-inch steel irrigation pipe through the levee, 6.0 feet below the crown. Siphon breaker in protective house at levee shoulder. Pump in pumphouse and power pole at landward toe. Pipe connected to 8-inch exposed pipe at landward shoulder, extending to pumphouse. Filter screen in channel at waterward toe. (Permit No. 15359-1990)
FS Date: 3/19/2009

Air vent located on pipe on landward.

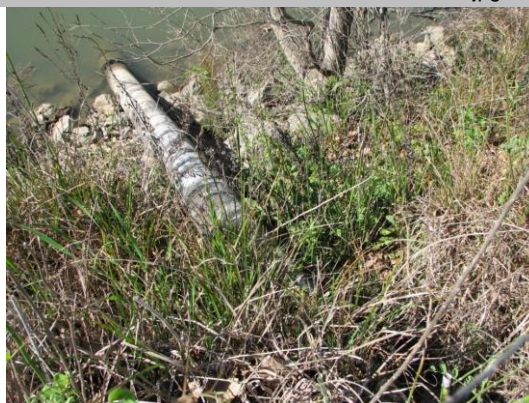
Photo 2 of 3 : UCIP_SP_2017_43431_36801.jpg

Pipe located on waterward side.

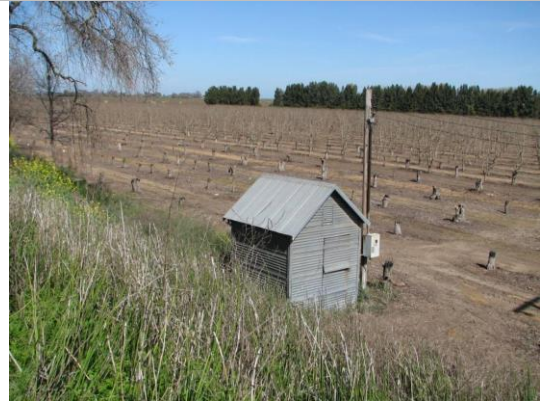
Photo 3 of 3 : UCIP_SP_2017_43431_36798.jpg

Item	DWR UCIP Field Study			38.316968 °	38.316968 °	
				-121.590219 °	-121.590219 °	
DWR ID						
Comment Code						
Inspector Comment						
FS_ID:43431 DS_ID:24186 EP_NO: 15359 Repair Type: Non-Urgent Crossing Status: Found UCIP Comments: Dense vegetation limits the inspector's visibility to identify signs of pipe failure (leaks) through the levee slopes. Recommend removing vegetation along pipe alignment to conduct proper inspection of structure and appurtenances. Note date on photos should be 3/18/09 not 7/26/08 camera metadata is incorrect. FIELD_STRUCT_DESC: 10-inch steel irrigation pipe through the levee, 6.0 feet below the crown. Siphon breaker in protective house at levee shoulder. Pump in pumphouse and power pole at landward toe. Pipe connected to 8-inch exposed pipe at landward shoulder, extending to pumphouse. Filter screen in channel at waterward toe. (Permit No. 15359-1990) FS Date: 3/19/2009

View of landward side.

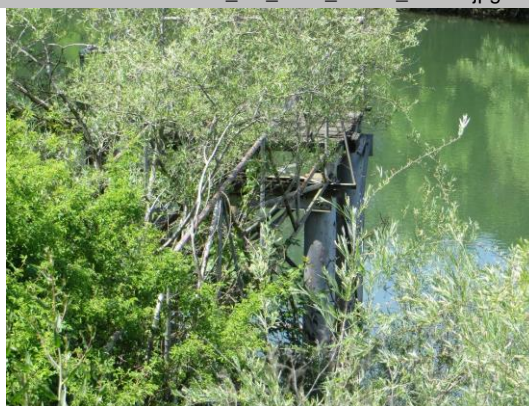
Photo 3 of 3 : UCIP_SP_2017_44391_73747.jpg

LM Start	5.19	Rating **	M	Issue No.	115 (cont)	
LM End	5.19	Issue Type +	En	Location *	CR	
Category	Supplemental			GPS Latitude/Longitude		
				Start	End	
Item	DWR UCIP Field Study			38.322460 °	38.322460 °	
				-121.589690 °	-121.589690 °	
DWR ID						
Comment Code						
Inspector Comment						
FS_ID:44391						
DS_ID:24189						
EP_NO: N/A						
Repair Type: Non-Urgent						
Crossing Status: Found						
UCIP Comments: Appears abandoned and if so should be done so properly.						
FIELD_STRUCT_DESC: 4-inch pipe through the levee, 3.3 feet below the crown. Gate and pump on platform at the landward toe (missing). Platform on the waterward side. (USACE-1959). This entry matches the Drainage or Irrigation Structure referenced in O&M manual (HLM 5.6).						
FS Date: 4/9/2015

Pier on WS toe.
